MASSIVE AMD RELEASE SPARKS COLLABORATIVE APPROACH TO WATERSHED RESTORATION

AN IMPERILED WATERSHED FINDS A FRIEND

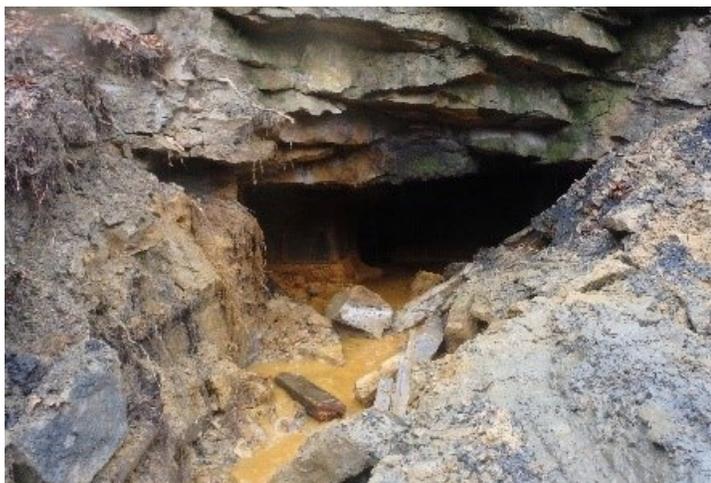
Figure 1. Left: Acid mine drainage (AMD) discharging from an abandoned mine. Right: Cheat River near Albright, WV.

In the spring of 1994, an illegally-sealed, major underground coal mine blew out a hillside near Albright, West Virginia, pouring millions of gallons of toxic, acid mine drainage (AMD) into a section of nearby Muddy Creek. The release entered the main stem of the Cheat River turning the river orange for miles. The acidic discharge lowered pH levels in Cheat Lake to 4.5, killing fish for miles downstream and negatively impacting the local recreational economy. A second blowout in 1995 further aggravated the problem and caused American Rivers, Inc., a national river conservation organization, to name the Cheat as one of the nation's ten most endangered rivers. Segments of the lower Cheat watershed are also listed on the State's 303(d) list for impairments related to AMD pollution (pH, dissolved aluminum, iron, and manganese).

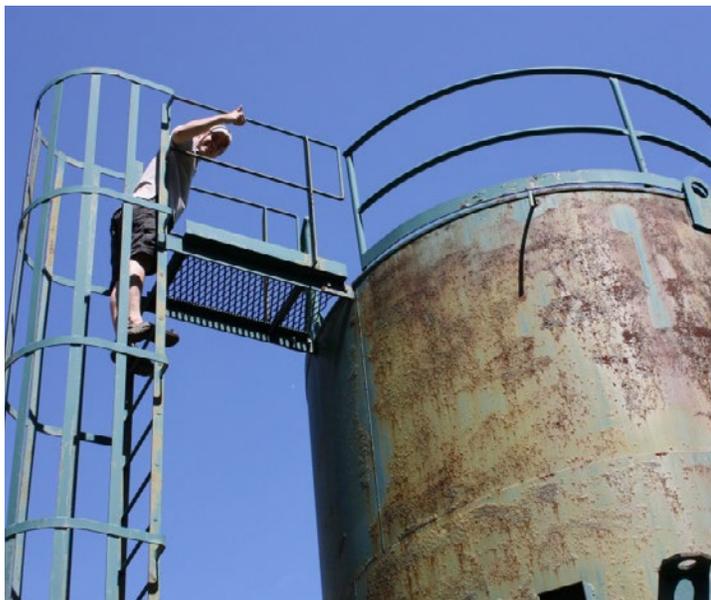
Figure 2 & 3. Left: Lime treatment silo. Right: Part of the DEP project staff discuss monitoring equipment.

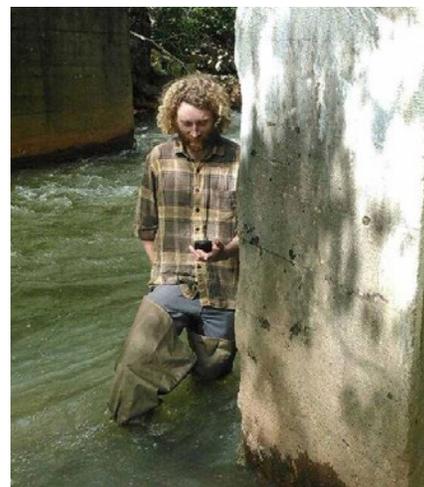
Figure 4. Bluetooth-enabled data sharing from the field.

All that changed when FOC learned of a multimeter that addressed the shortcomings. The In-Situ Aqua TROLL 600 Multiparameter Sonde included the parameters of interest, as well as a LCD screen with a visual display to show battery life and log status. The instrument also utilizes wireless Bluetooth technology coupled with the VuSitu Mobile App, allowing technicians to share data with the team right from the stream.

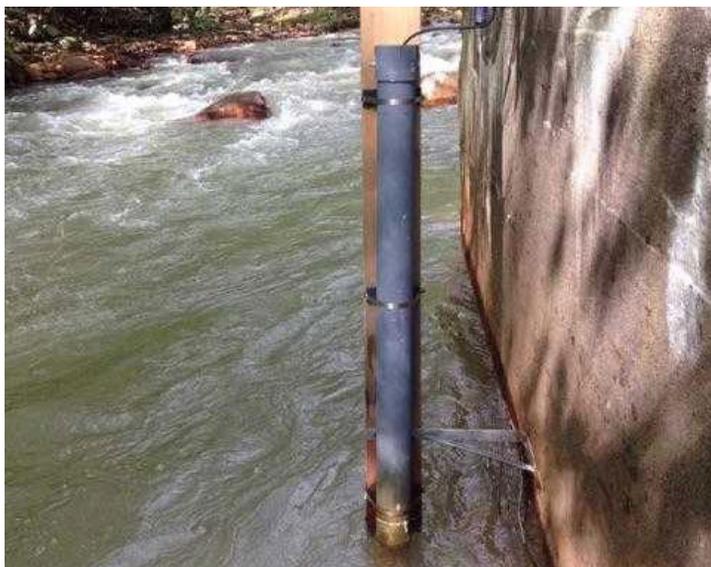
Figure 5. Aqua TROLL 600 deployed in a stilling well at the mouth of Muddy Creek.

Field Technicians were bringing the units back to the office every two weeks to clean them and conduct other maintenance functions. The Aqua TROLL 600's unique wiper and flat-faced sensor design minimizes maintenance requirements allowing for longer deployments.

The technological advancements of the Aqua TROLL 600 took the program to a new level that wasn't possible before. Turbidity, pH, depth, dissolved oxygen, conductivity, and temperature readings are recorded every 15 minutes and averaged hourly. As a result, the monitoring program is now more regimented, and FOC gets consistent water quality data to inform decisions.

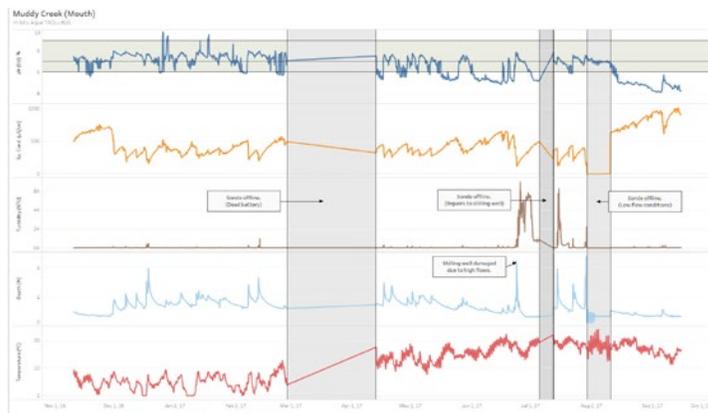
Figure 6. Continuous water quality data from the Aqua TROLL 600 Multiparameter Sonde.
